# Manhole Inspection Summary

Manhole # S53I\_\_030MH

Insp Date: **9/16/09 8:56 AM**

**Location** Address: **behind 3031 Eastern Ave.**

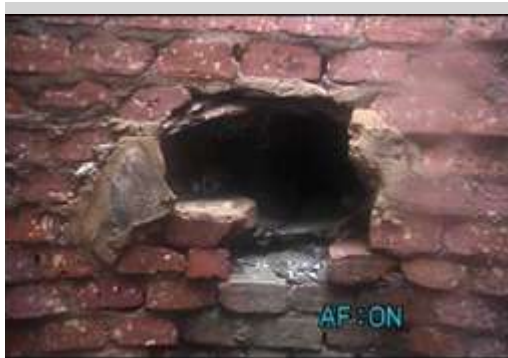
Defect 4

Condition: ☐ Sound ☐ Cracked ☐ Root Intrusion ☒ **Loose Brick** ☐ Deteriorated

loose/missing brick in barrel wall around upper connection@6

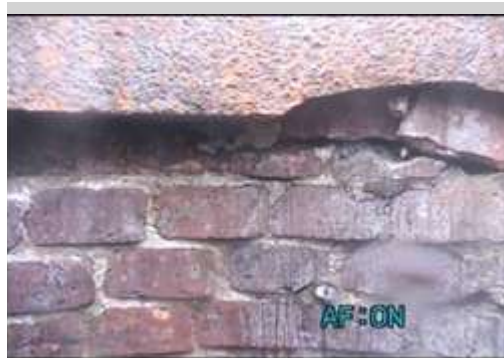
Defect 3

Condition: ☐ Sound ☒ **Cracked** ☐ Leaks

Condition: ☐ Sound ☒ **Cracked** ☐ Root Intrusion ☒ **Loose Brick** ☒ **Deteriorated**

corbel cracked & deteriorated with loose brick; frame cracked/broken

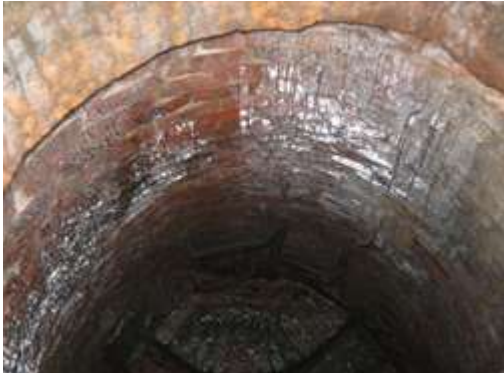
### Defect 2

Missing: **2**

☒ **Corroded**

missing and corroded rungs

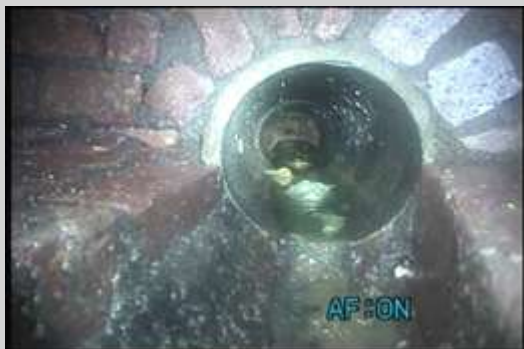
4 O'Clock Inflow

looks to be a seriously misaligned joint about  
2ft outside MH

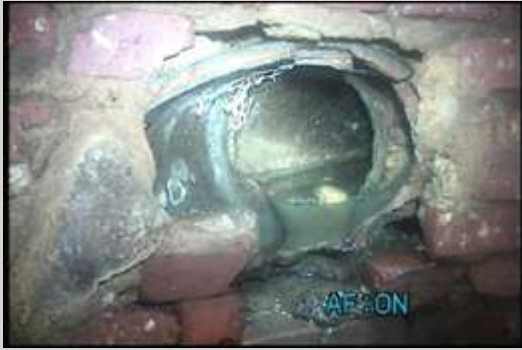
6 O'Clock Inflow

Pipe Height: **6** (in.) Rod and Bar (Angled)  
Pipe Material: **Clay** ☐ Pipe Lined  
Invert Depth: **4.80** (ft.) Flow Characteristics: **None**  
Deposits: ☒ None ☐ Mud ☐ Sludge ☐ Debris ☐ Grease  
Silt Depth: **0** (in.) Deposits Extent:  
Infiltration: **None** Pipe Seal Cond: **Broken**

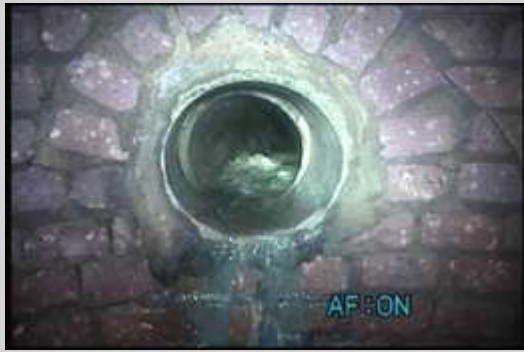
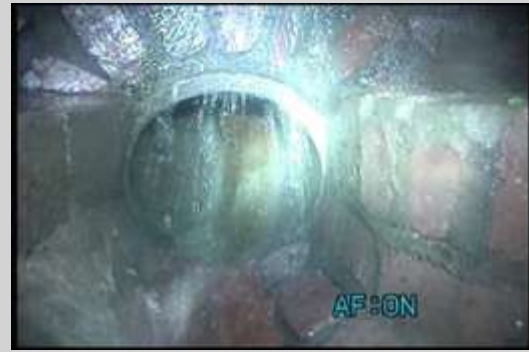
Drop In @ 9 OClock

Drop Condition: **Clogged**
